RECONNAISSANCE LEVEL SURVEY FOR ALOHA STADIUM

PREPARED BY:
FAI ARCHITECTS

PREPARED FOR:
CRAWFORD ARCHITECTS
JANUARY 24, 2025
FINAL

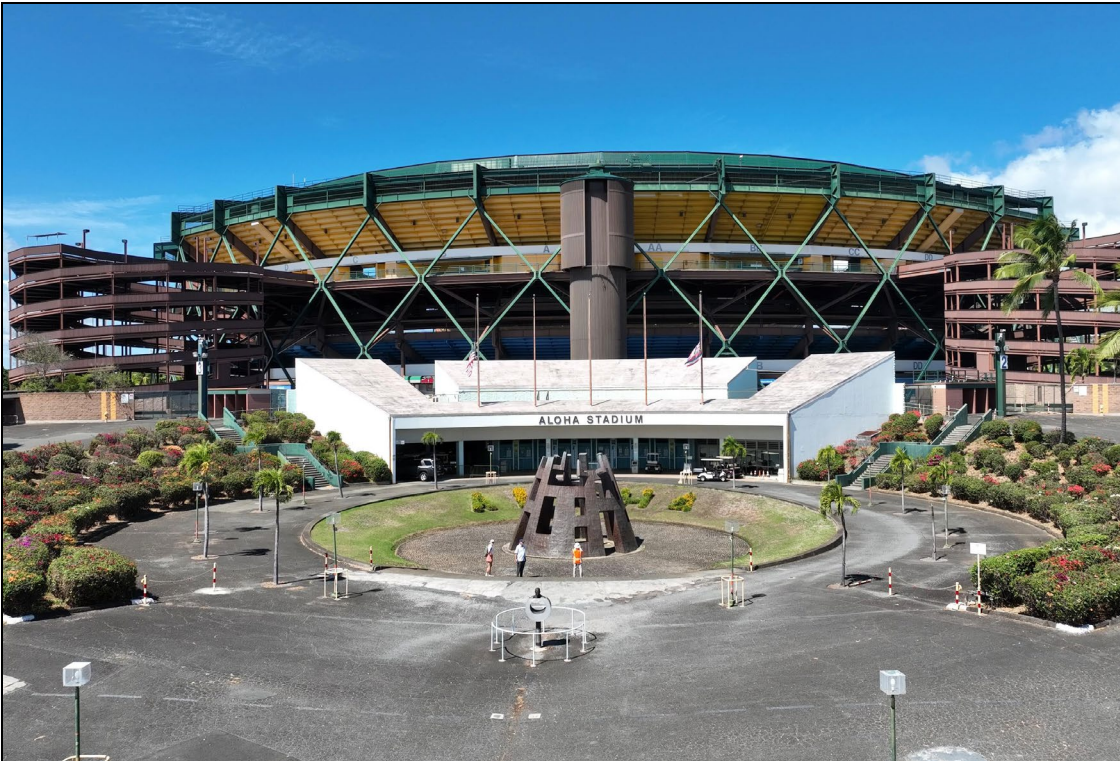
The stadium's curved main entry and box offices face south. The box office projects out from the stadium and a four-story cylindrical elevator shaft clad in ribbed metal siding rises from the rear of the box office. The box office looks out upon the south entry plaza. The south entry plaza sits in a bowl below the level of the stadium with the floor of the bowl sloping down towards the south parking lot. The plaza is open on its south side, allowing entry and egress. In the center of this opening a bronze bust of Governor John Burns by University of Hawaii art professor Fred Roster sits atop a circular base supported by a cylindrical shaft. This statue was dedicated in 1981.

Figure 1: Southern view of Aloha Stadium entrance. Box office and southern concession stand are visible in front of stadium. Entrance drive landscaping and bronze volcano sculpture are visible in foreground.

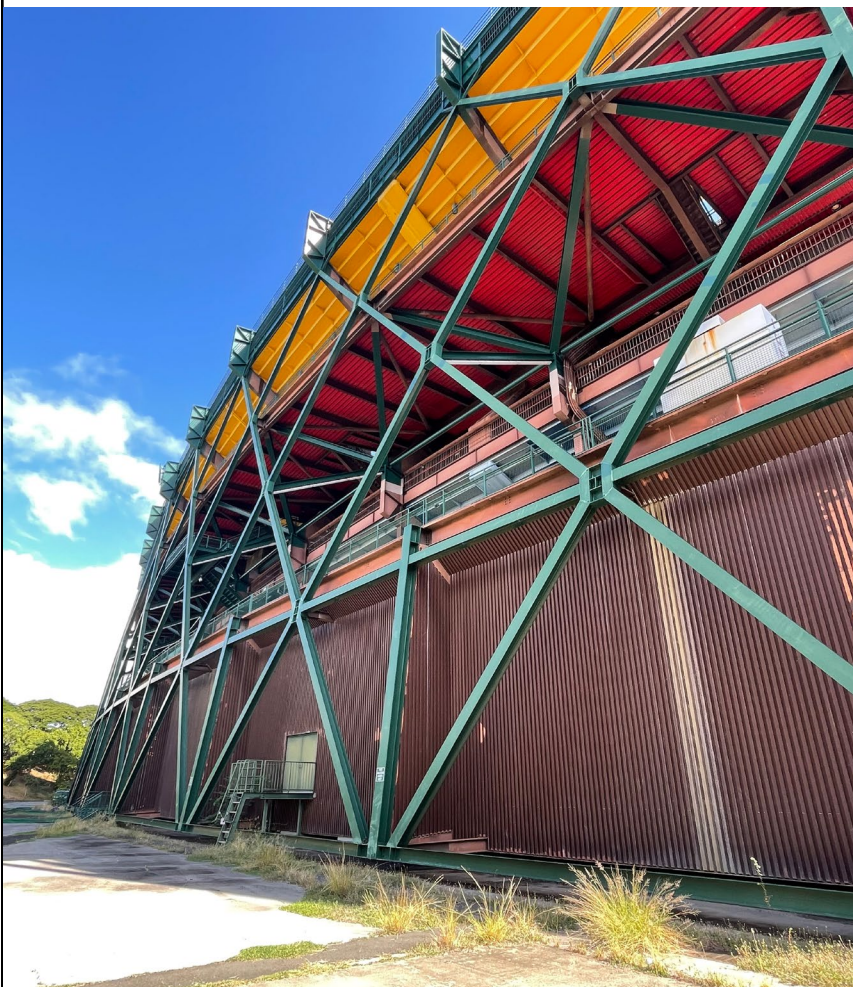
Figure 2: Exterior of stadium at southwestern corner. Corten steel structure is visible as well as ribbed steel walls around base.

- Corten steel construction
- Crossing exterior support system
- Ribbed metal cladding
- Modern, angular design

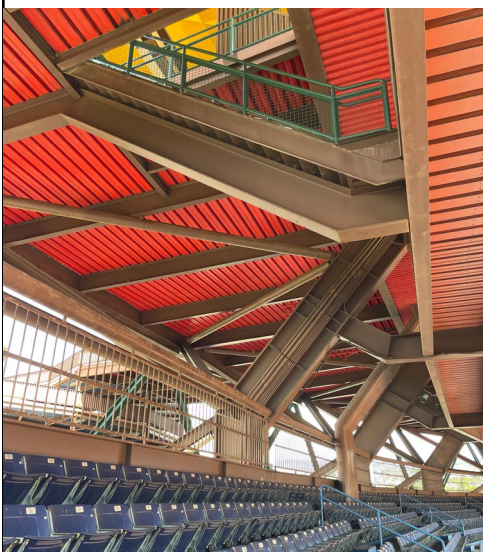
Figure 5: Corten steel structure supporting the upper tiers of the stadium. Replacement railings visible in upper tier.

- Corten steel structure
- Ribbed metal cladding
- Color-coded seating

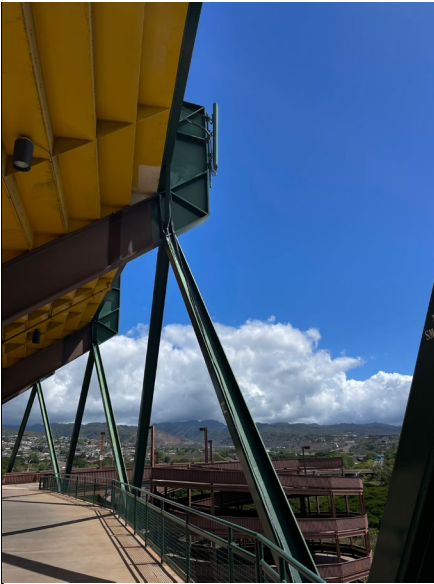
Figure 6: Pedestrian exterior walkway along upper tier showing replacement railing and corten steel structure.

- Corten steel structure
- Modern, angular design

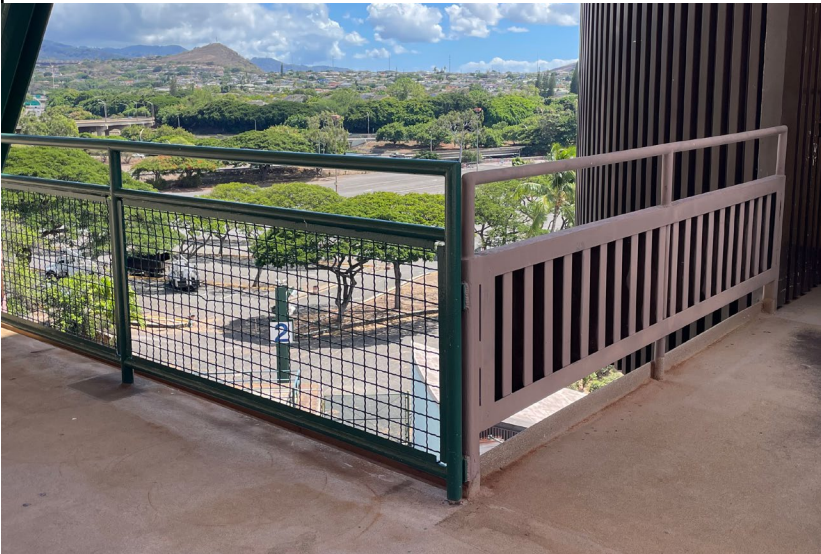
Figure 7: Replacement and original railing present near the elevator shaft at the southern end of the stadium.

- Replacement metal wire railings

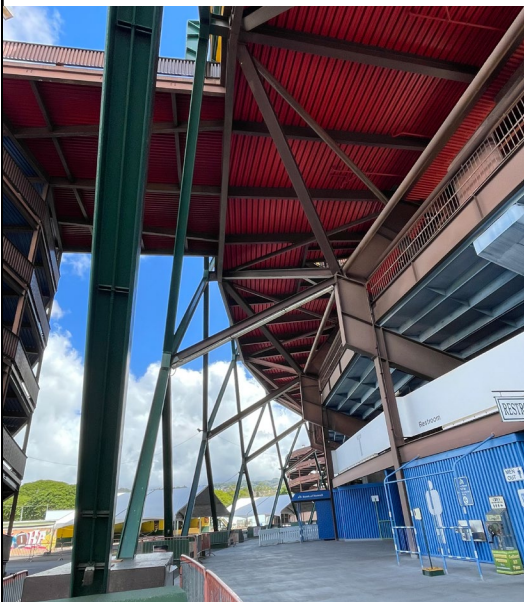
At the four corners of the stadium are large circular pedestrian ramps which provide vertical circulation for the spectators. The spiral ramps have a split face CMU foundation and rise six spirals into the air. A 3'-6" high guardrail with ribbed metal siding runs around the sides of the ramps and a pipe handrail runs down the center of each walkway. A flat slab bridge at the top of each of the four ramps connects to the upper concourse of the stadium.

Figure 8: Lower pedestrian walkway at southwestern corner of stadium. Pedestrian ramp visible to the right. Bathrooms with ribbed metal siding visible in bottom left.

- Corten steel structure
- Ribbed metal cladding
- Spiral pedestrian ramp

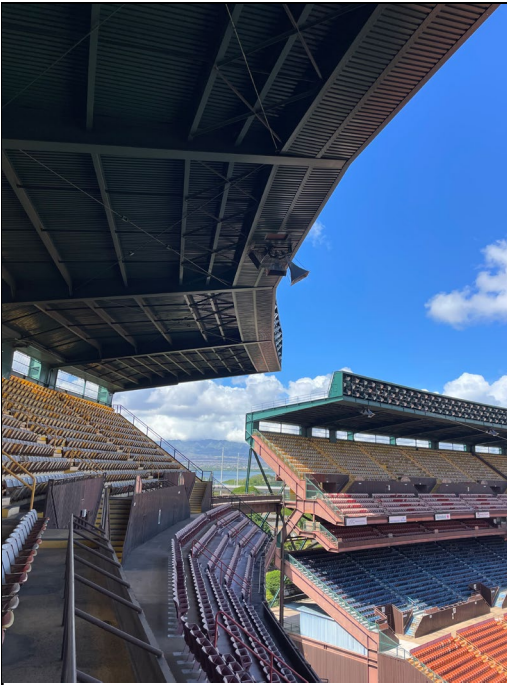
A 53' wide metal roof, which replaced the original, protects the grandstand seats from rain. Rising from the roof is an 11'-6" high light box which contains the field lights. The speakers for the stadium are attached to the eaves of the roof.

Figure 9: Western moveable sections visible from upper tier of southern fixed section. Original field lighting and speakers visible on roof.

- Ribbed metal roofing
- Two-tiered design
- Field lights
- Color-coded seating

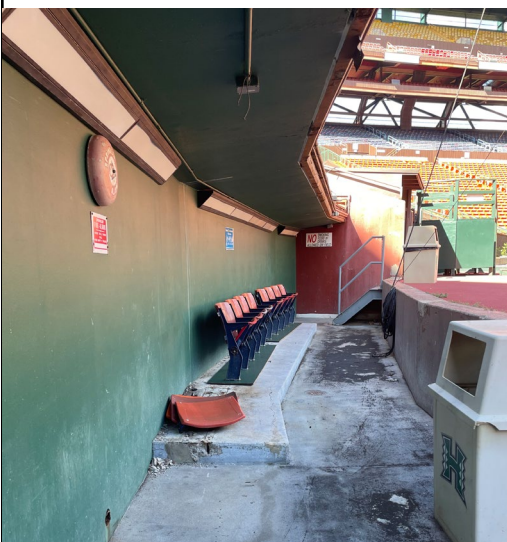
Figure 11: Center dugout at south end of stadium. Seating has been removed.

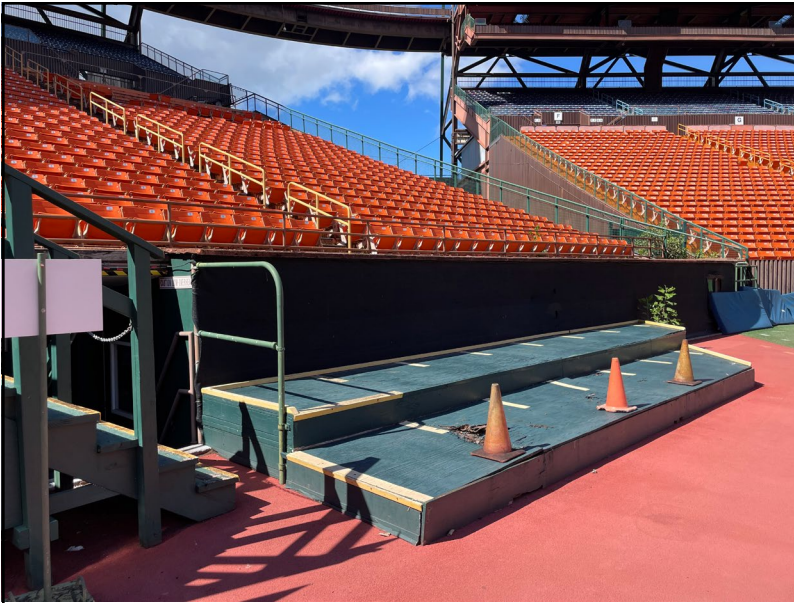
Figure 12: Enclosed eastern dugout now converted to VIP room at south end of stadium.

- Enclosed dugout

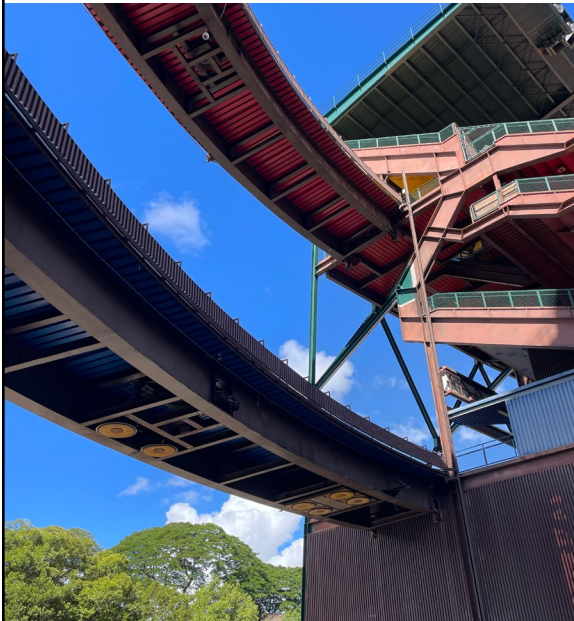
Figure 13: Moveable pedestrian walkways at southwest corner of stadium. Moveable walkways are found at four corners of the stadium.

- Replacement railings

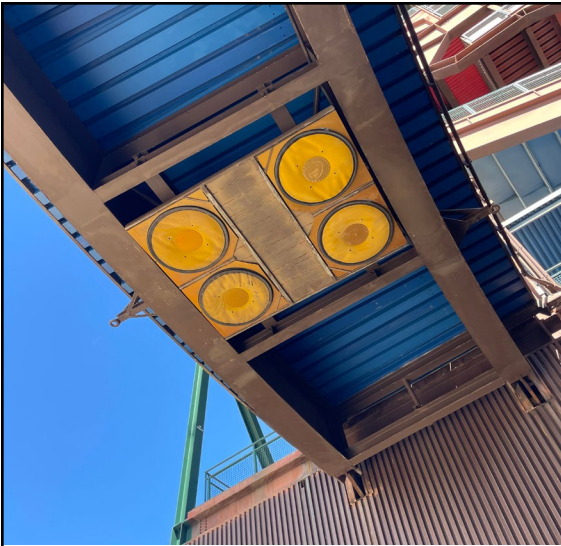
Figure 15: Air movement system ball bearings visible on underside of pedestrian bridges.

- Moveable pedestrian bridges
- Ribbed metal cladding
- Air movement system

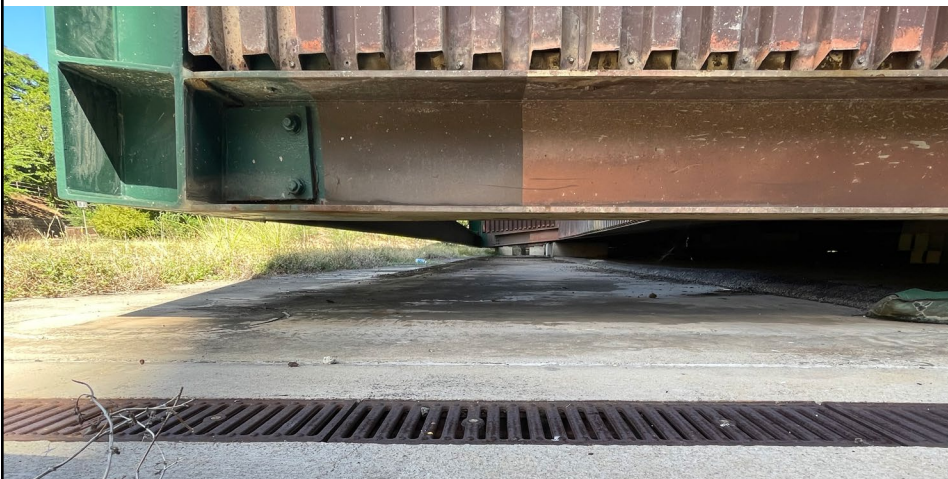
Initially, the stadium had permanent concrete stands holding 11,000 seats at its north and south ends and a pair of moveable steel frame stands on both the east and west sides. Each of the four mobile sections contains 7,000 seats. Each section of seating, both permanent and mobile, features cross bracing on its exterior perimeter. Portions of the cross bracing's concrete foundations have been removed to reveal extensive rusting at the base.

Figure 16: Base of moveable stadium section hovers above cement movement pad.

- Corten steel structure
- Moveable stadium section

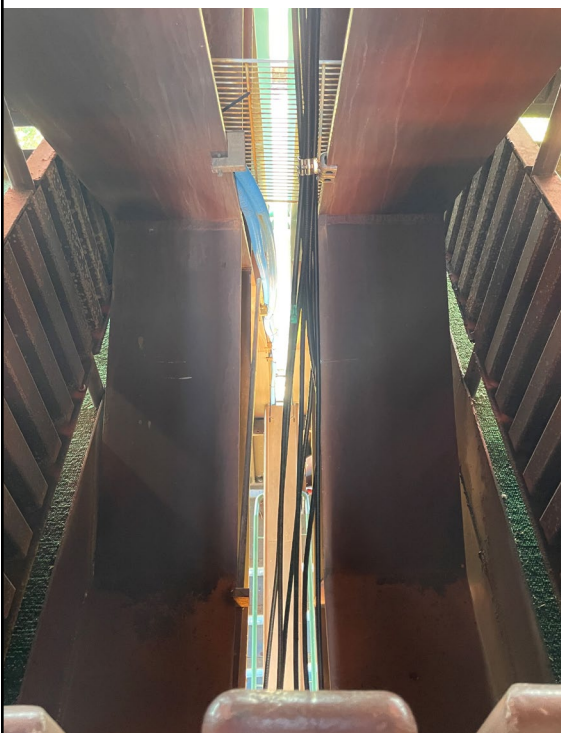
Figure 17: Meeting point of two moveable stadium sections showing corten steel structure.

- Corten steel structure
- Moveable stadium section

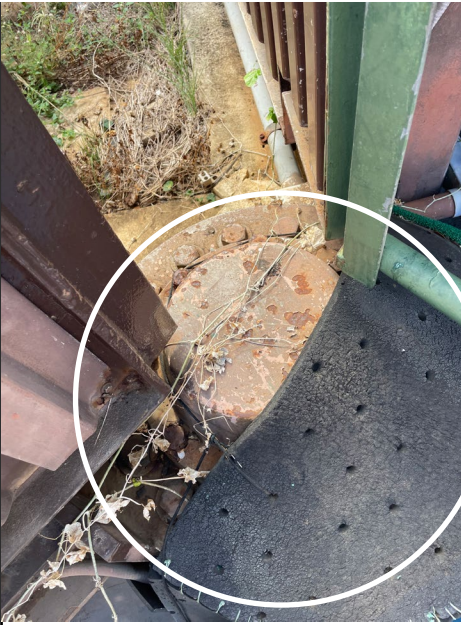
Figure 18: Massive hinge where moveable and stationary stadium sections meet.

- Moveable stadium section

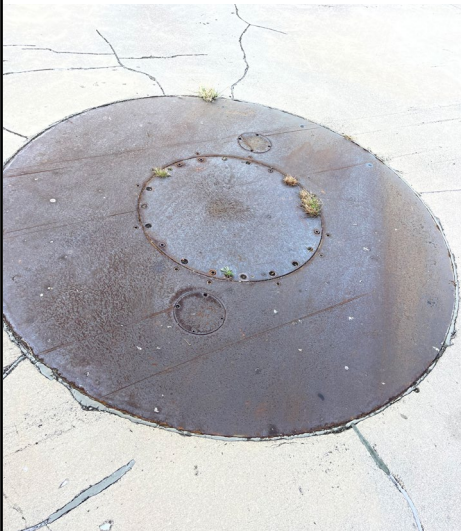
Eight bridges at the middle and upper concourse levels span the approximately 100'-0" wide gaps between the concrete and once mobile sections of the stands. These curving bridges have 2'-6" high railings clad in ribbed metal with a 1'-0" pipe rail above. On the underside of the lower bridges, yellow discs may be observed. These are the remains of the "air film" transporters manufactured by Rolair Systems, which facilitated the moving of the bridges. The bridges are now locked in place but originally had to be put up and taken down whenever the stadium seating was reconfigured. At ground level below the bridges are staging areas for the handling of the bridges. Centered under the bridges are 7'-3" diameter circular steel plates each housing a 3'-0" diameter hydraulic ram which is the shaft of a hydraulic piston that is anchored in concrete 104'-0" below the surface.

Figure 19: Piston cover for pedestrian bridges.

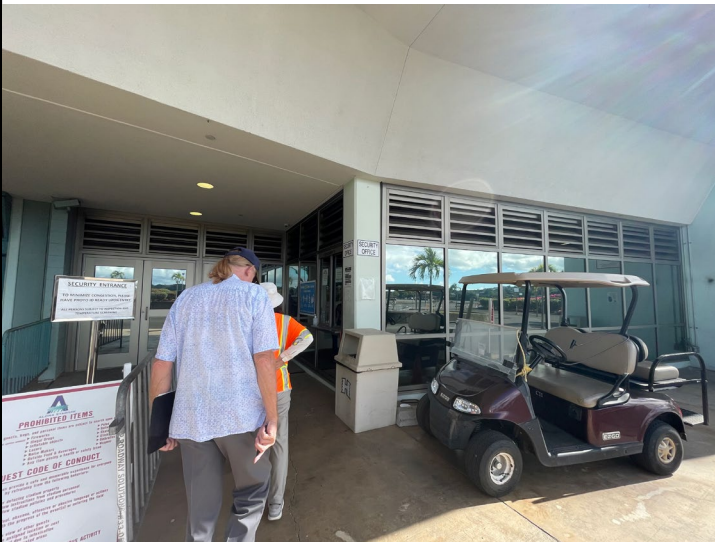
Figure 28: Infill windows and doors in eastern bay of box office & stadium main entrance.

- Enclosed pedestrian passageway and new security office

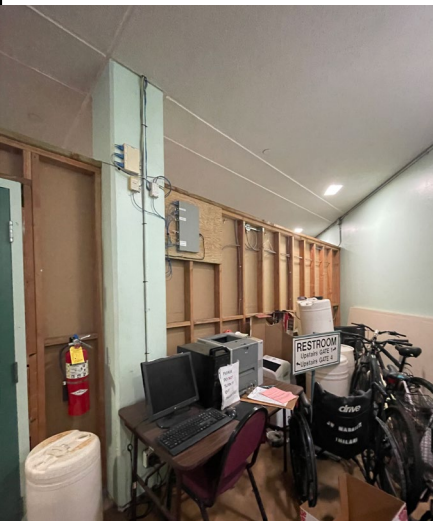
Figure 29: Infill wall where box office entrance was modified.

- Enclosed pedestrian passageway and new security office

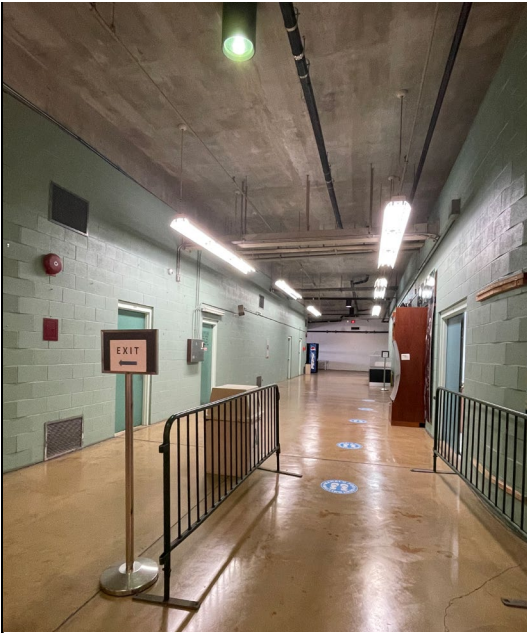
Figure 30: Interior hallway behind box office showing concrete block walls, finished concrete floors, and exposed utilities on ceiling.

- Concrete block walls
- Polished concrete floors
- Open construction ceilings

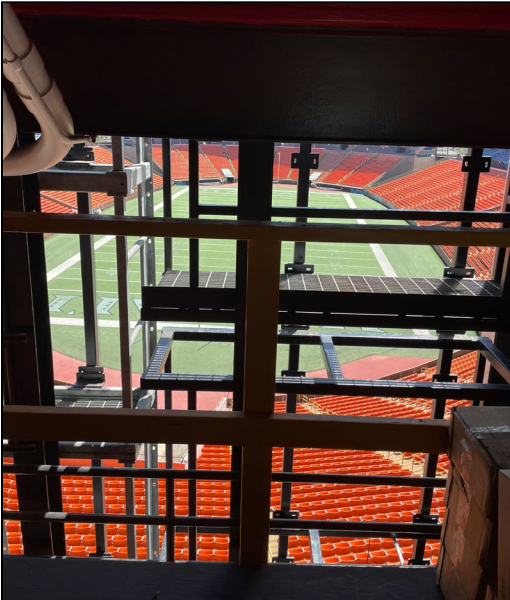
Figure 36: Scoreboard support structure.

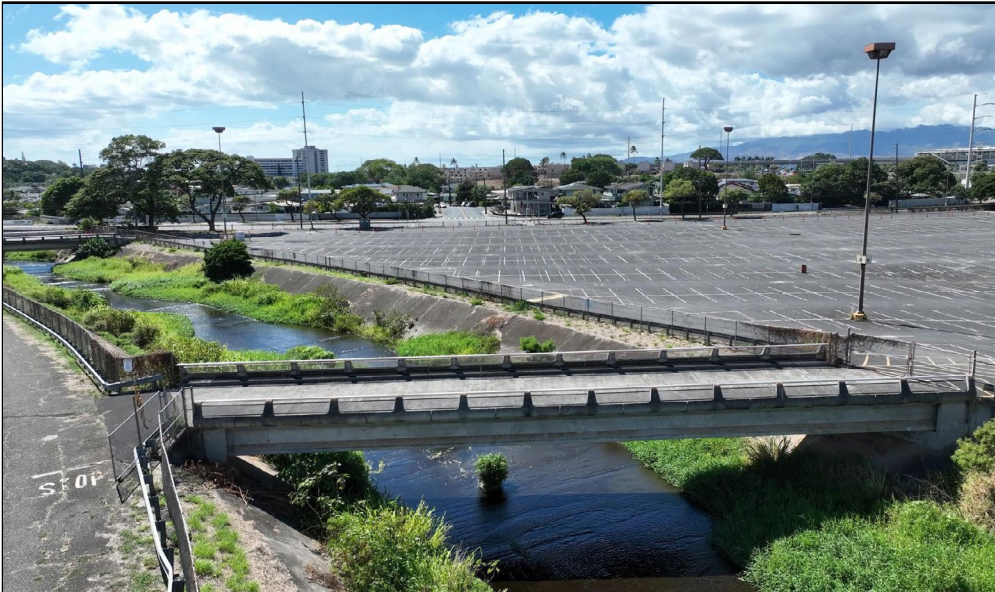
Figure 42: Halawa Stream bridges with middle bridge in foreground and eastern bridge in background.

- Cast and reinforced concrete construction
- Curved concrete parapets
